UV Fluorescence for Defect Detection in Residential Solar Panel Systems

Andrew M. Gabor and Philip Knodle

BrightSpot Automation LLC, Westford, MA, 01886, USA

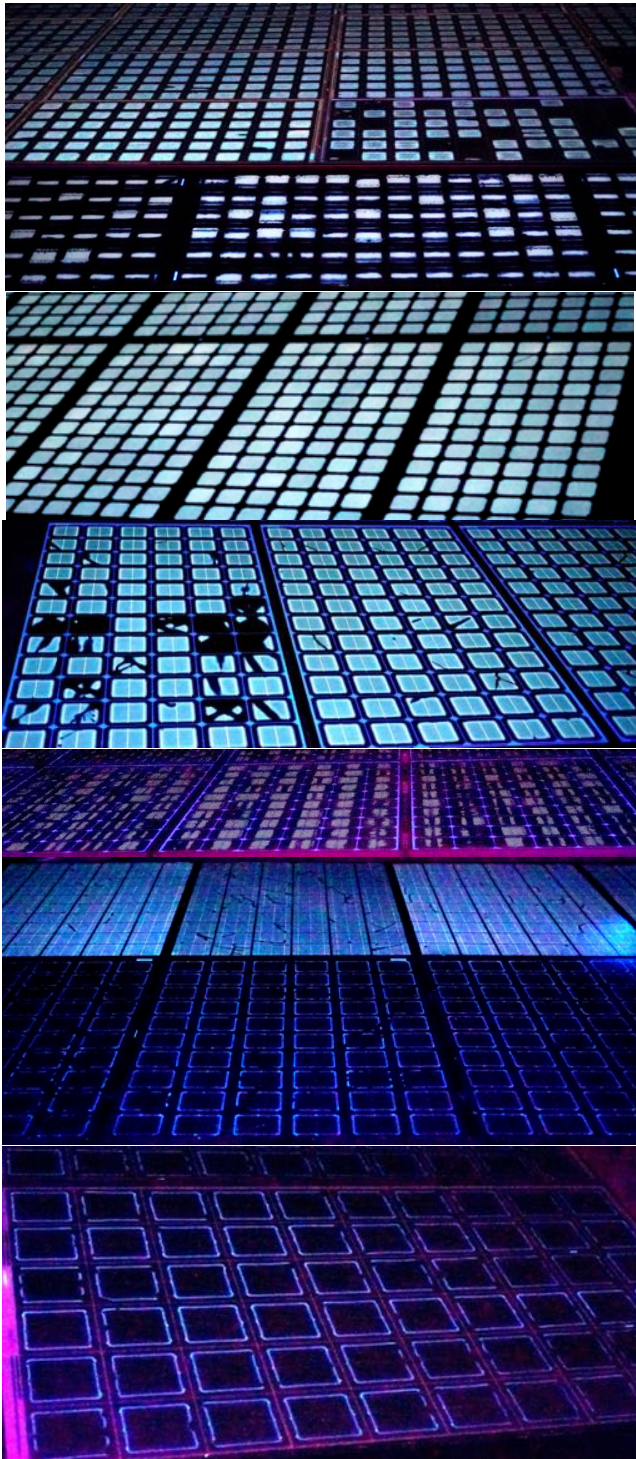
Roughly 2/3 of the systems with useful images showed significant levels of cracked cells (see Fig. 2). The dark bands corresponding to crack locations varied from <2mm to >2cm. Some cells with apparently high levels of cell cracking appeared entirely dark. In contrast to EL imaging which cannot detect cracks that are located underneath the busbars and interconnect wires, with UVF we saw that cracks in these locations were quite common. Although such cracks do not cause an immediate problem, they do represent a possible source of new branching cracks as the panels are further stressed with mechanical loading events and thermal cycling. Modules with *ring-pattern* fluorescence are more challenging to interpret, but breaks in the bright rings clearly correspond to cracks that intersect the ring. In a system that contained 2 different type of panels, both pattern types were seen. In a ground mounted system, we observed snail trails in cells during daylight, and these corresponded perfectly with the crack locations seen by UVF as is seen in Fig. 3.

Fig. 2. UVF images showing cracked cells

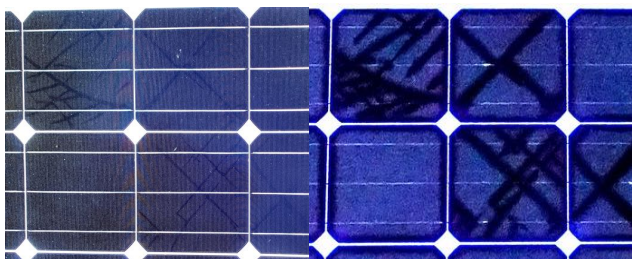
Fig. 3. Daylight photograph (left) showing snail trails, and a UVF image (right) showing cell cracks in identical locations.

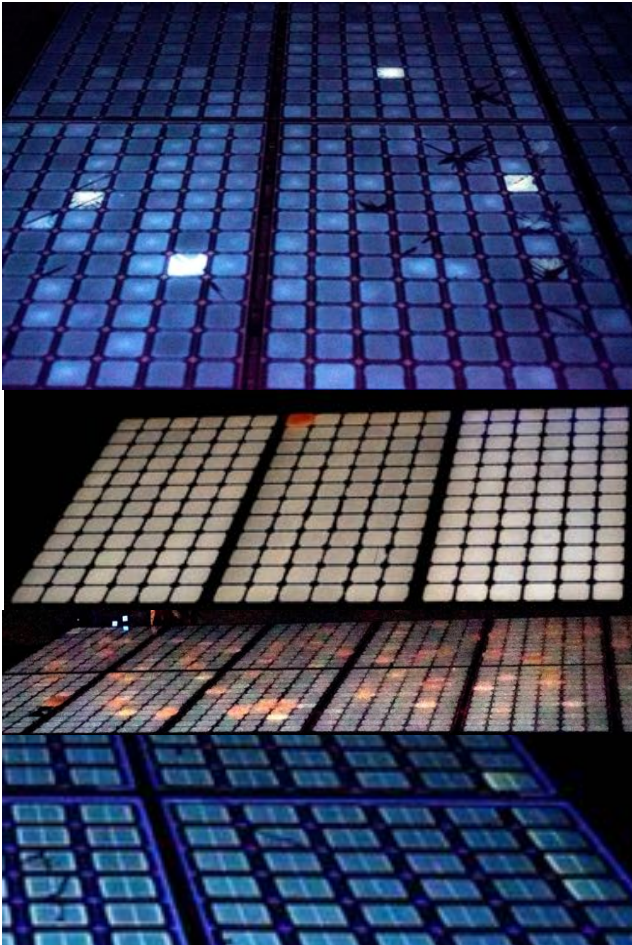
Roughly 20% of the systems with useful images showed scattered cells which fluoresced much more brightly than neighboring cells, appearing either white or orange in color (see Fig. 4). We interpret this to be due to cells which have run hot at some point during their history due to entering reverse bias from shading events, or cracked cells with reduced active area, or interconnect wire bonding problems. The higher temperature operation can accelerate the reaction which causes the encapsulant to fluoresce, and if the encapsulant yellows or browns, this can impart an orangish color to the UVF image of these cells.

Fig. 4. UVF images showing cells with hot spots

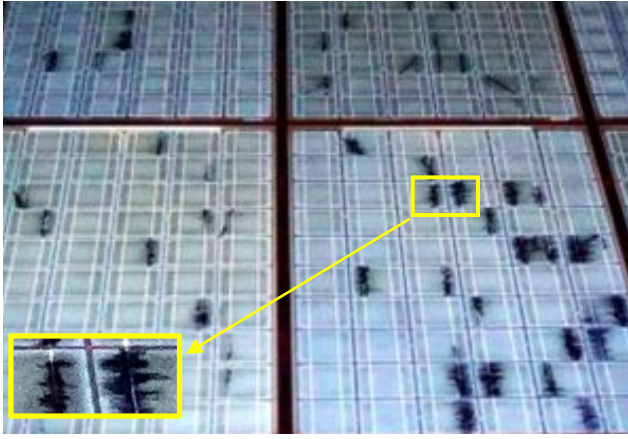
Another defect seen in one system (see Fig. 5) had dark lines branching along the finger directions, perpendicular to the busbars. The cause of the pattern is unclear, but could be linked to silver finger corrosion [1] or delamination of the front encapsulant along the finger that allows oxygen from an intersecting crack to travel along the linear delamination void. If this is true, UVF could prove to a valuable tool for detecting such defects.

Fig. 5. UVF image exhibiting possible finger corrosion or delamination

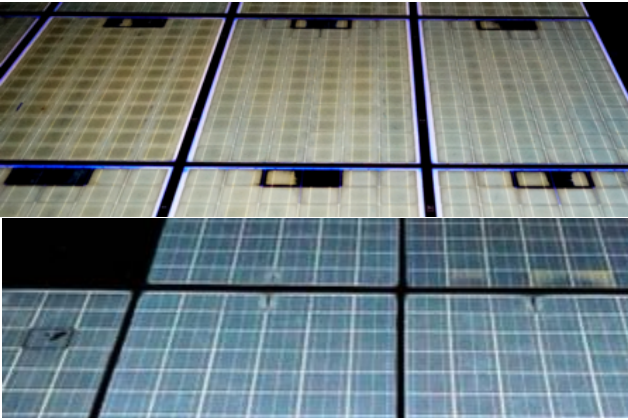
A variety of other curiosities are seen in Fig. 6. In some cases brighter regions are seen near junction box locations, possibly indicating hot-running bypass diodes, and in other cases darker areas are seen by the junction boxes, indicating seals which allow more oxygen to enter the module. In one case a dark area is seen around a cell, indicating possible repair/rework performed during manufacturing.

Fig. 6. UVF images exhibiting other interesting patterns
