UV FLUORESCENCE IMAGING OF DEFECTS AND BILL OF MATERIALS VARIATIONS IN BIFACIAL SOLAR PANELS

Andrew M. Gabor¹, Maulid Kivambe², Mohamed Abdelrahim², Mohamed Elgaili², Amir A. Abdallah²

²Qatar Environment & Energy Research Institute (QEERI), Hamad Bin Khalifa University (HBKU), Doha, Qatar

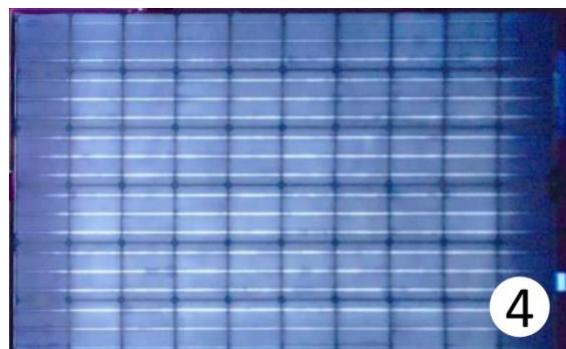
Fig. 1: Taken from [4]. UVF image of a glass/glass panel with oxygen quenching near the short ends and apparently by some interconnect wires.

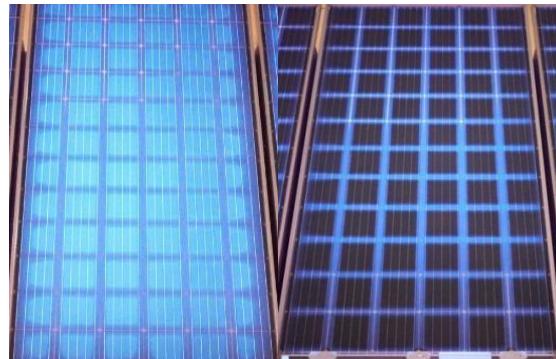
Figure 2 shows UVF images of two Heterojunction (HJT) panels with identical model numbers but which show the incorporation of a different front encapsulant layer. The panel on the left has a front encapsulant which fluoresces strongly and where oxygen is apparently diffusing inward both from the panel edges as well as from the gaps between the cells to produce a darker ring around each cell where the fluorophores are partially quenched. It is unclear why oxygen diffuses so uniformly through these gap regions when the source of the oxygen is presumably only from the perimeter of the panels. In contrast, the panel on the right displays ring pattern fluorescence, where the front encapsulant did not incorporate UV absorbing additives, but where fluorophores from the rear encapsulant are diffusing through the gaps and across the surface of the cells. In both cases, oxygen has diffused in

from each long edge up to the first interconnect wire to produce a dark band along each long edge. It is unclear whether the abrupt ending of oxygen quenching at the first interconnect wire is a coincidence, or whether perhaps the thinner region of encapsulant between the glass and wire reduces the inward diffusion of the oxygen. If the kinetics of oxygen diffusion can indeed be affected in this manner, perhaps this effect could be intentionally designed into oxygen and moisture sensitive panels.

Fig. 2: UVF images showing BOM variations in the front encapsulant layer for the same model number of HJT panels installed in 2020. PR = 92.7%.

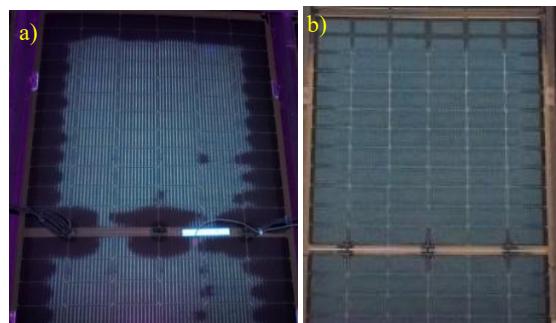
Figure 3a shows a UVF image taken from the back side of a different HJT panel type where oxygen is diffusing inward from both the edge perimeter regions as well as through the 3 junction box penetrations. It is interesting to note that the diffusion front from each long edge shows that oxygen appears to have diffused inward faster over the middle regions of the cells. In contrast, the UVF image taken from the front side in Figure 3b shows the oxygen diffusing inward more strongly from the gaps between cells, but overall that the quenched regions reach less far inward than on the backside, perhaps due to the differences in UV additives within the encapsulant layers or the different UV aging doses experienced on the front and back sides. Also, there are some scattered dark spots seen on the rear side that are unexplained. It is possible that these correspond to cell crack locations, but it is not clear why enhanced oxygen diffusion would take place from the front side.

Fig. 3: a) UVF image from the rear side of a HJT panel showing oxygen diffusing through holes in the glass for junction box penetrations, varying degrees of oxygen diffusion from the perimeter, and a few unexplained dark spots; b) UVF image from the front side of a panel of the same model. Panels installed in 2020. PR = 94.7%

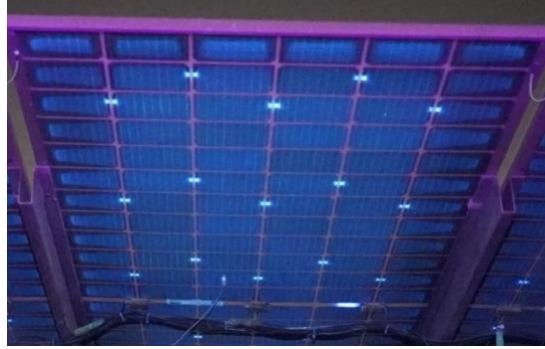
Fig. 4 shows another example of strong rear side fluorescence where oxygen is seen diffusing inward from the perimeter in a PERC panel. In contrast with the panel shown in Figure 3, there the diffusion appears to be occurring more rapidly in the gaps between cells. Also, here the sealing around the junction box penetrations appears to be more effective.

Fig. 4: UVF image from the rear side of a PERC panel showing oxygen diffusing inward from the perimeter. Panels installed in 2018.

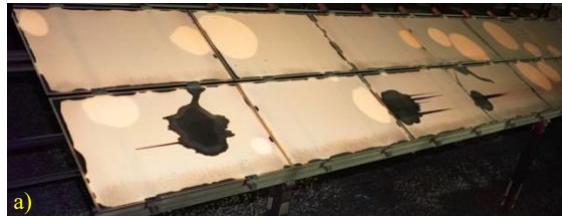
We also collected UVF images from thin-film CIGS panels. Although these panels were not of a bifacial design, these data points have high importance in evaluating the potential for UVF in imaging thin-film panel defects. Figure 5 shows the UVF image of panels where the CIGS is deposited on the rear glass in a substrate type configuration and the encapsulant between the CIGS and the top glass is fluorescing brightly. Each panel displays some degree of sealing problems on the edges, but in 3 of the panels, there are large dark regions emanating from an edge which incur deeply into the panel central regions. In some cases narrow dark lines extend down the length of the scribed cells. It is not clear why oxygen can diffuse down the length of a cell, but perhaps the scribing process in some cases leaves channels that are not fully filled with encapsulant or where delamination is occurring. These correspond to white regions by eye. Each panel also displays some large brighter regions that can be seen by eye as light brown spots where perhaps hot spot heating has occurred.

Fig. 5: UVF image of CIGS panels showing likely sealing failures and possible delamination (dark spots) and bright regions where possible hot spot heating has occurred. Panels installed in 2015.

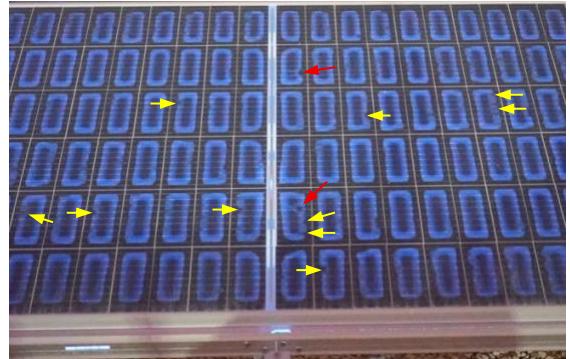
Figure 6 shows a UVF image of a TOPCon panel with ring pattern fluorescence where variations in the ring pattern likely correlate to cell crack locations. Most cracks appear to be near interconnect wire locations where the oxygen quenching leads to dips in the outer perimeter of the rings near the wire locations. In a few examples, diagonal cracks

show bright lines in the center of the cells where fluorophores are diffusing through the cracks from the rear encapsulant and where oxygen has not diffused in from the cell perimeter to quench that fluorescence.

Fig. 6: UVF image of a TOPCon panel where breaks and variations in the ring patterns likely correspond to cell cracks. Yellow arrows show cracks that may lie underneath busbars, while red arrows show cracks that propagate between busbars. Panels installed in 2022 at a fixed tilt southward of 22 degrees. PR = 96.0%.

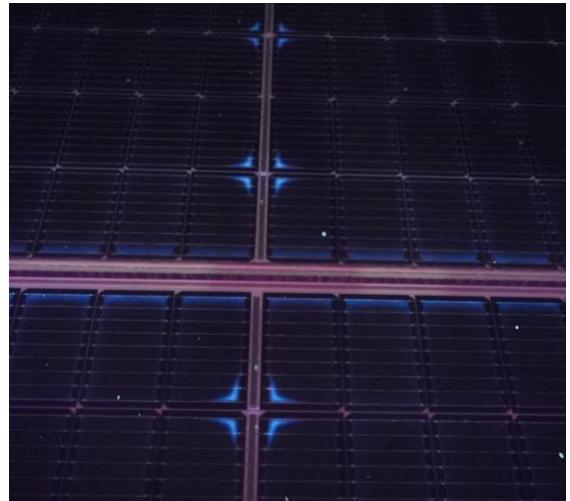
Figure 7 shows a UVF image of a PERC panel with no visible fluorescence anywhere except near the junction boxes and the perimeter frame. We assume the fluorescence has evolved preferentially in these locations due to resistive heating in the junction boxes and due to regions near the frame running hotter than elsewhere. The competing kinetics of fluorescence activation from heat and fluorescence quenching from oxygen diffusion through glass penetrations and edges give rise to complex patterns.

Fig. 7: UVF image showing the effect of hotter regions near the junction boxes and the perimeter of a PERC solar panel. The competing kinetics of fluorescence activation from heat and fluorescence quenching from oxygen diffusion through glass penetrations and edges give rise to complex patterns. Panels installed in 2018.

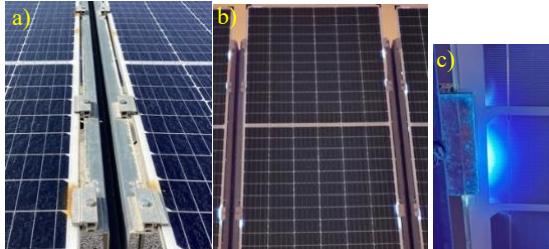
Figure 8a shows frameless PERT panels where some clamping positions where shifted after some years of operation and where there may be local heating near the clamp positions. The regions around both the old and new clamping positions shows visible browning above the

white regions at the perimeter of the panels. The glass surface was manually scrubbed to verify that the discoloration was not due to residue on the top surface of the glass. Possible causes of the discoloration are due to hotter internal panel temperature under the clamp positions or diffusion of some chemical species from the polymer used in the clamps. Figures 8b and 8c show UVF images of the panels where the browned regions fluoresce strongly but where there is little other fluorescence in the panel. The fluorescence appears quite strong over the cell regions close to the clamps, and it is possible that the strong fluorescence correlates to hot spot regions.

Fig. 8: a) RGB image of frameless PERT panels where some clamp positions had been shifted after some years of field operation; b) a UVF image of the same panels, and c) a closeup UVF image near a clamp position. Panels were installed in 2020.
