Re-Evaluating Solar Panel Mechanical Durability Testing: Case Study of Commercial Modules

Eric J. Schneller^{1,2}, Hubert Seigneur², Jason Lincoln², Joseph Walters², Andrew Gabor³

²Florida Solar Energy Center, University of Central Florida, Cocoa, FL USA

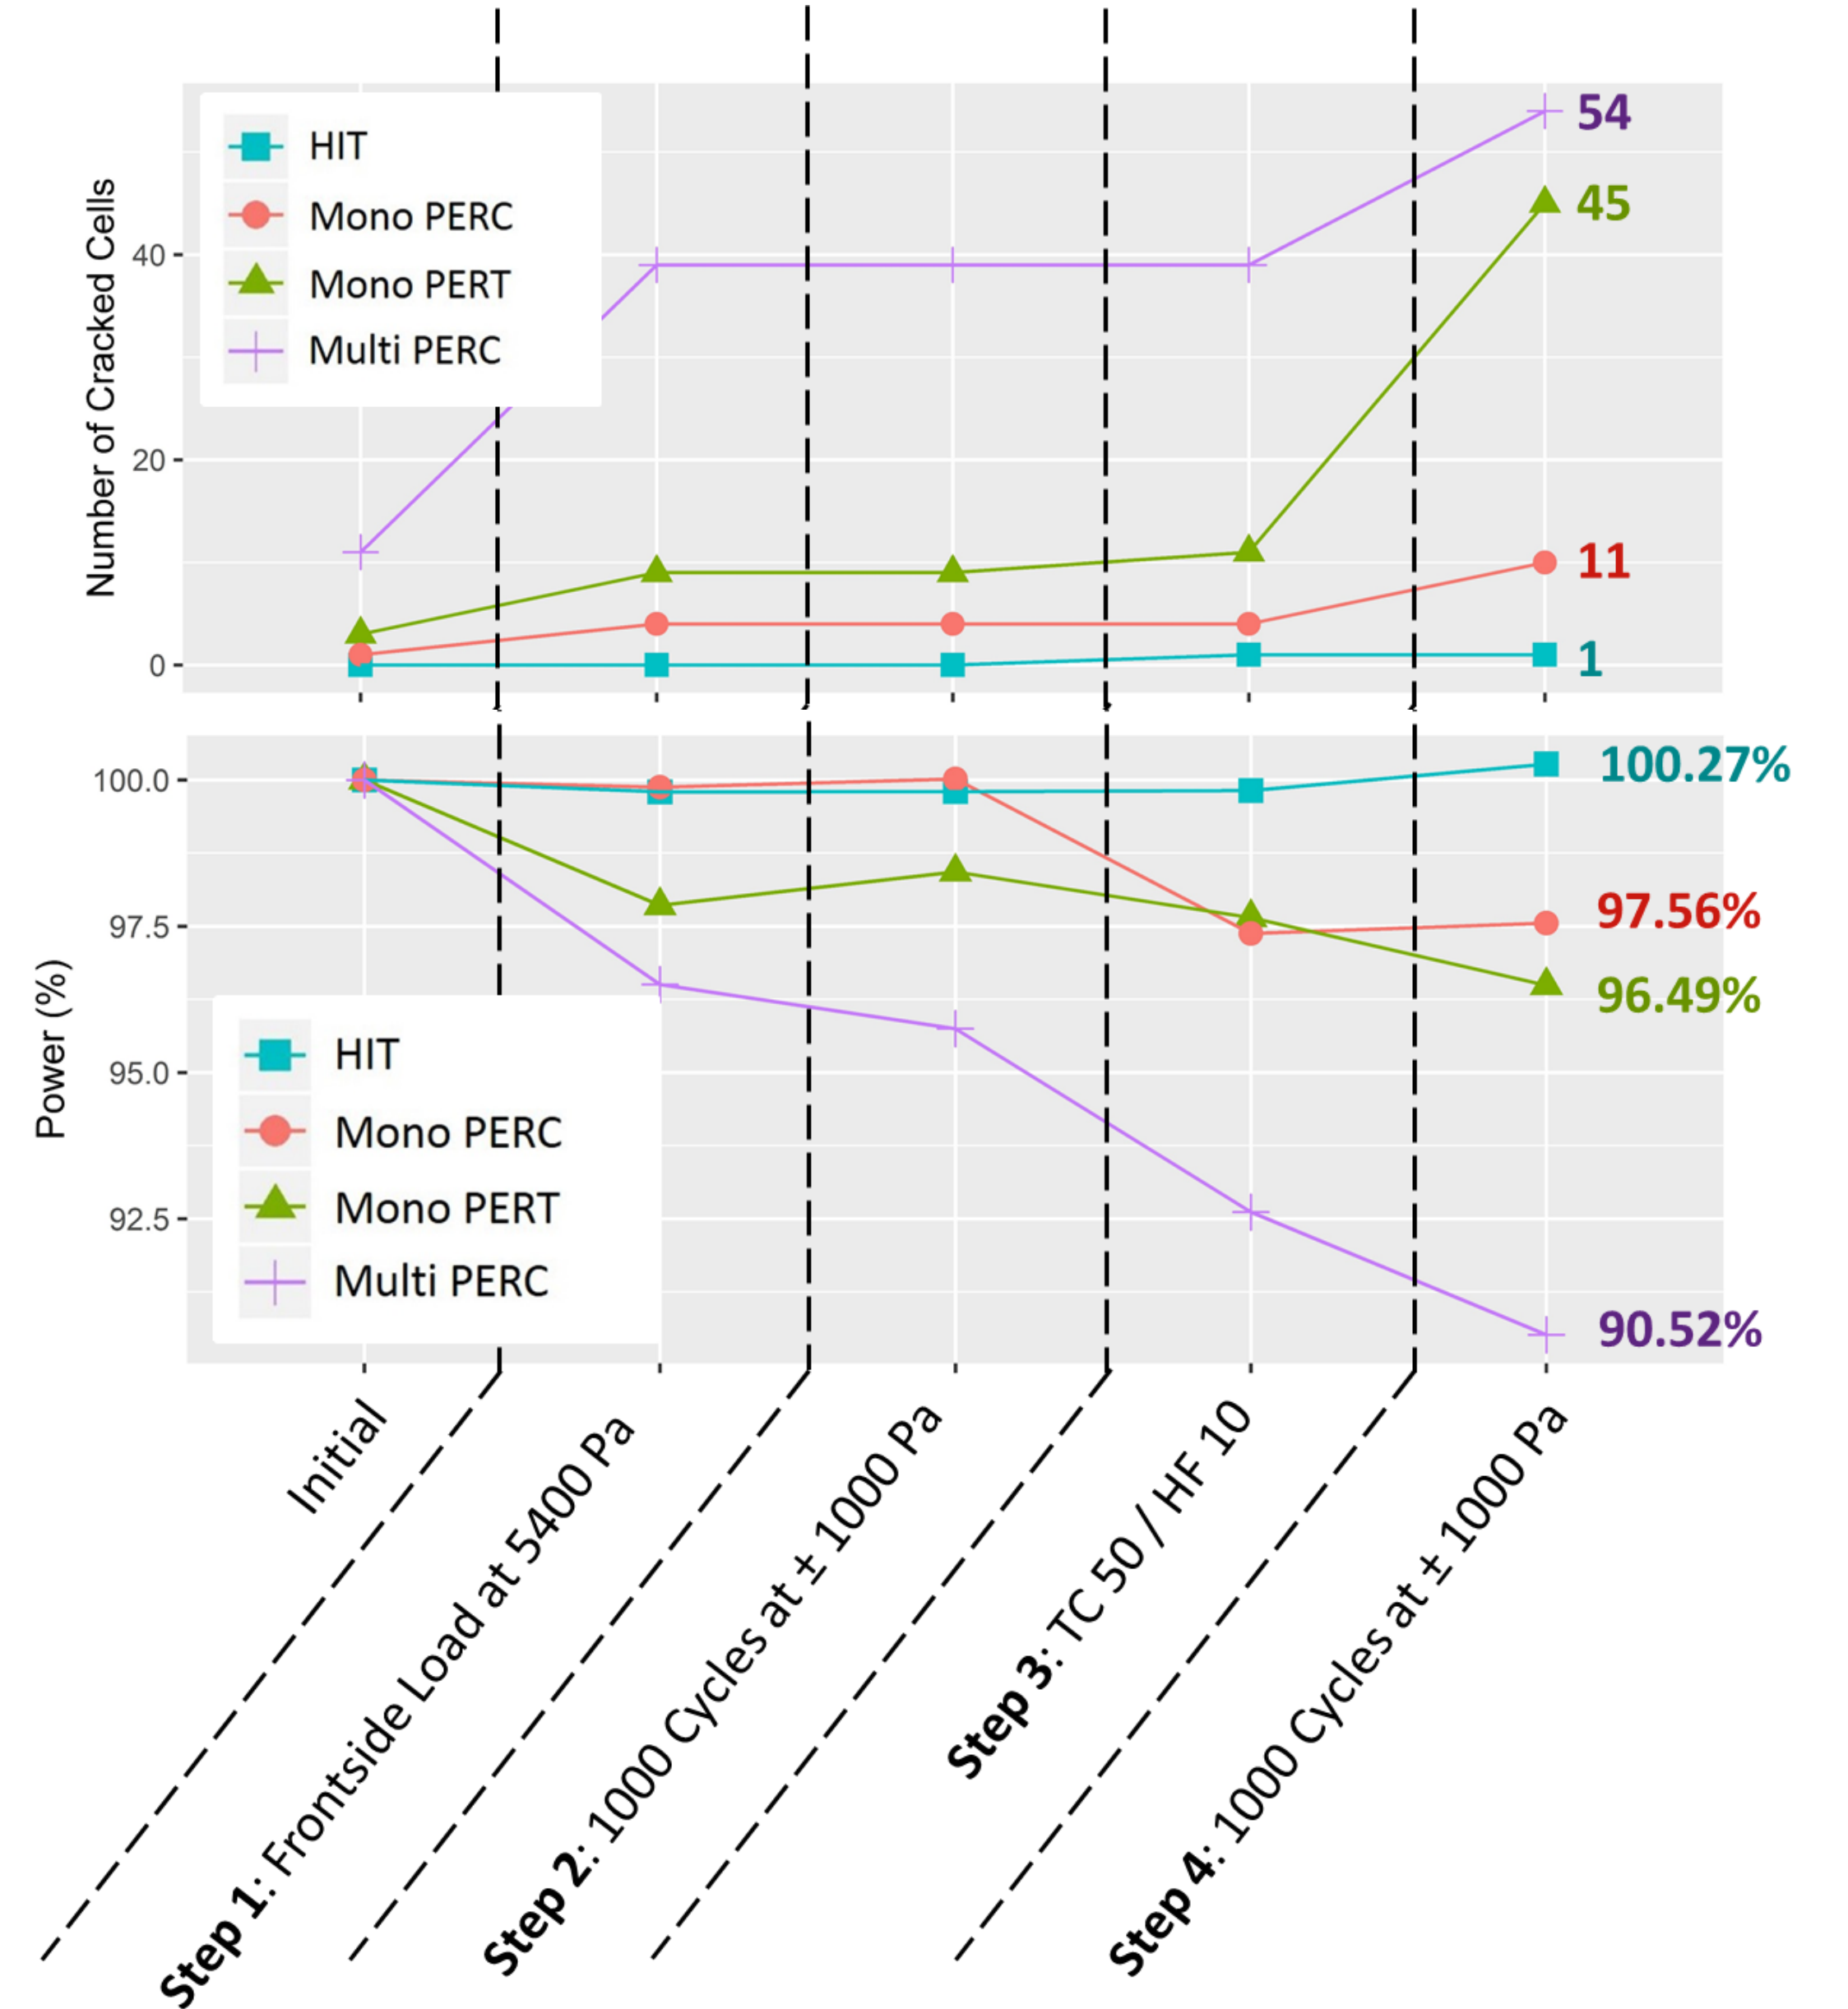
I-V data was captured to assess the impact on performance due to each exposure step. In addition, the number of cracked cells was counted to identify which exposure steps contributed to cell cracks.

- Large variation in crack durability across commercially available modules
- Mechanical loading after thermal cycling causes a significant number of new cracks for modules with solder interconnects
- Heterojunction modules, utilizing a symmetric cell structure and low temperature interconnect process, exhibit high durability with respect to crack generation
