UV Fluorescence for Defect Detection in Residential Solar Panel Systems

Andrew M. Gabor and Philip Knodle

BrightSpot Automation LLC, Westford, MA, 01886, USA

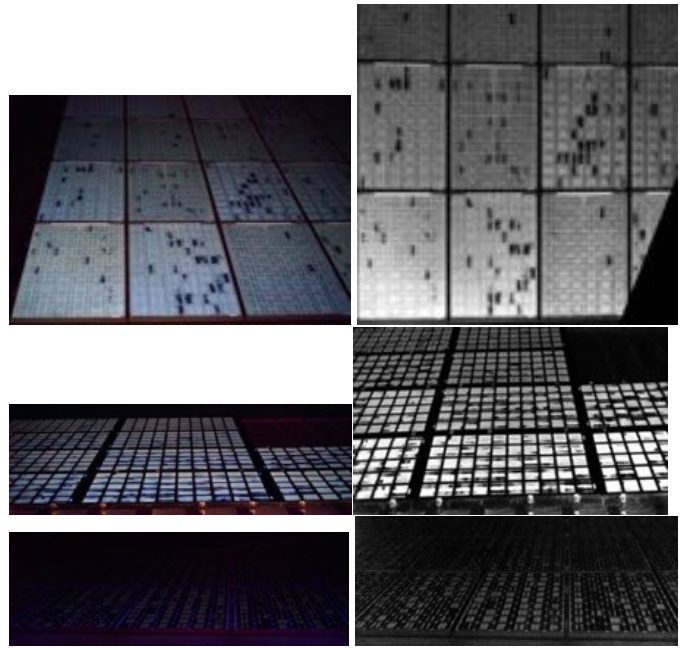
Fig. 7. Examples of automatic UVF image enhancement through the unoptimized IMPEL software.

Automatic enhancement of images through BrightSpot's IMPEL software is demonstrated in Fig. 7. Enhancement steps include in order, vignetting correction, barrel distortion correction, contrast improvement, and perspective adjustment. Note that IMPEL was developed for enhancement of single module EL images. Customization of the software for UVF specific requirements will be implemented in the future. In addition to these image enhancements, we will also implement machine learning based approaches that will likely include the segmenting out of individual modules images and cell images, and automatically detecting and quantifying different defect types. Some possibilities for defect categories include:
