Cracked Up: how should we classify and respond to various electroluminescence defects in

silicon PV modules?

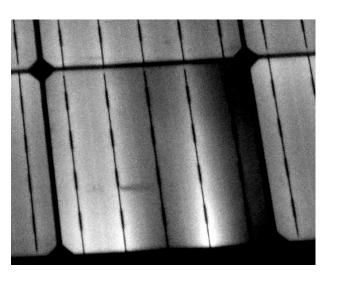
Dark finger regions consistently going up to busbars: Likely cracks in fingers but not in Si; poor metallization and/or tabbing process/design

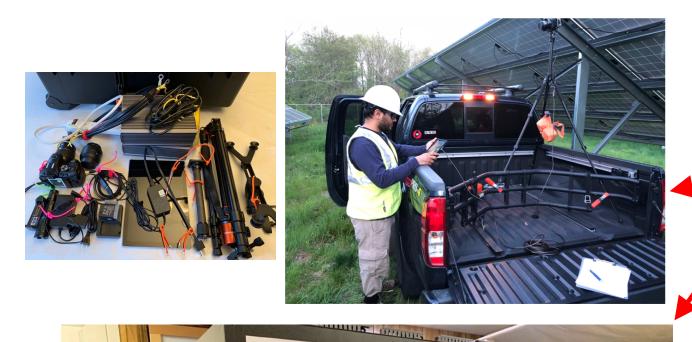
Systems	Throughput (modules/hr with 2 workers)	Pros	
Tripod systems	20-60	Lowest cost Easy to transport	
Trailer systems	40-120	Best quality images Reproducible conditions Can do IV and other tests Can test during daytime	[]
Drone systems	>120	Fastest Best for difficult to access installations

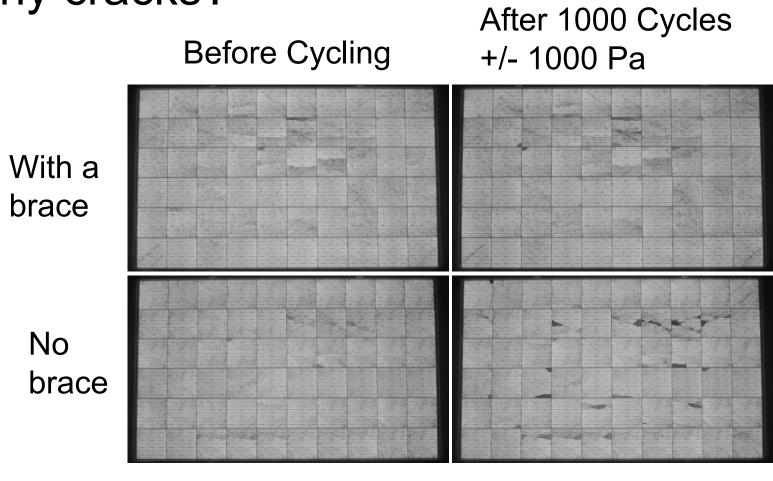
Adding a brace can limit deflection vs load and prevent crack opening or even close opened cracks³

Example of a brace that presses on back side

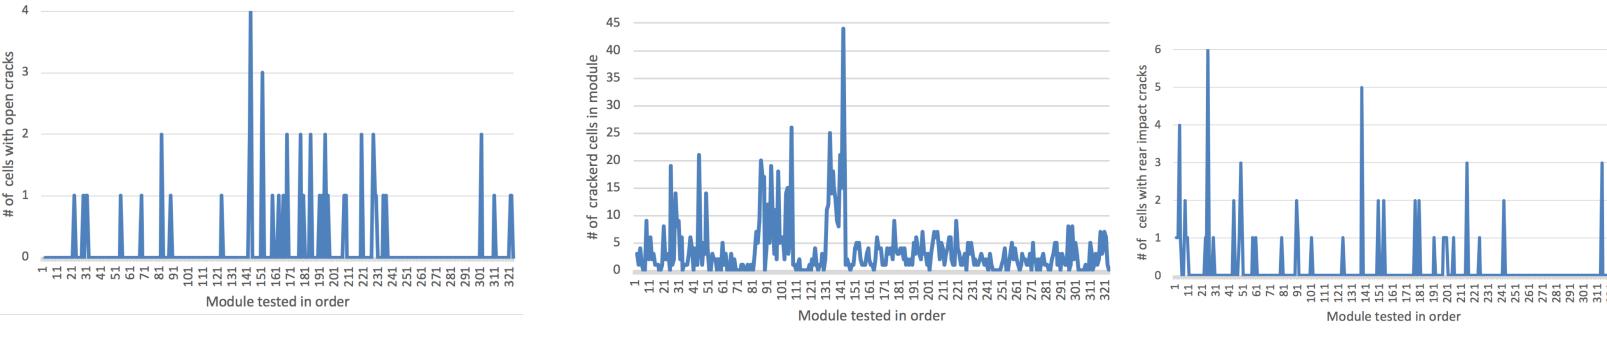
- Keep track of cracks in key categories: Closed, Open, Rear Impact Important to automate detection and quantifications
